BEEHCRAFT

I. INTRODUCTION

II. BEEHCRAFT ACCIDENTS

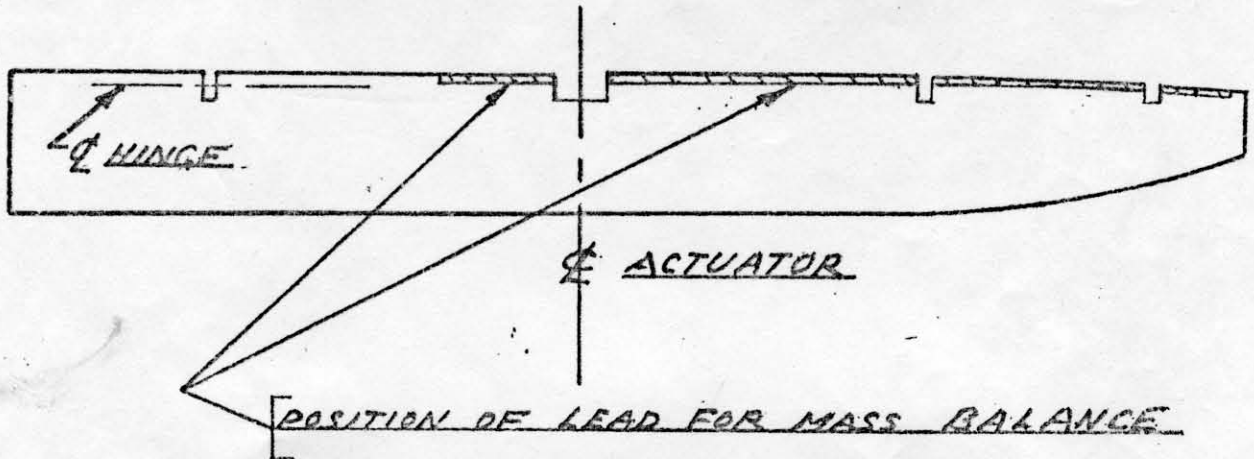
FIGURE 1

MASS BALANCE OF
BIT & C17 AILERONS

1. Lead should be placed in the aileron as shown in figure 1.

For complete instructions concerning Models B17 and C17 aileron mass balance, notice "Beechcraft Service Bulletin No. 76."

THE AMOUNT OF LEAD TO BE ADDED IS
DETERMINED BY THE ORIGINAL BALANCING
CONDITION OF THE AILERON. SUFFICIENT
LEAD MUST BE ADDED TO AT LEAST COM-
PLETELY STATICALLY IT. A LITTLE OVER
BALANCE IS PERMISSABLE, BUT NO
UNDERBALANCE.

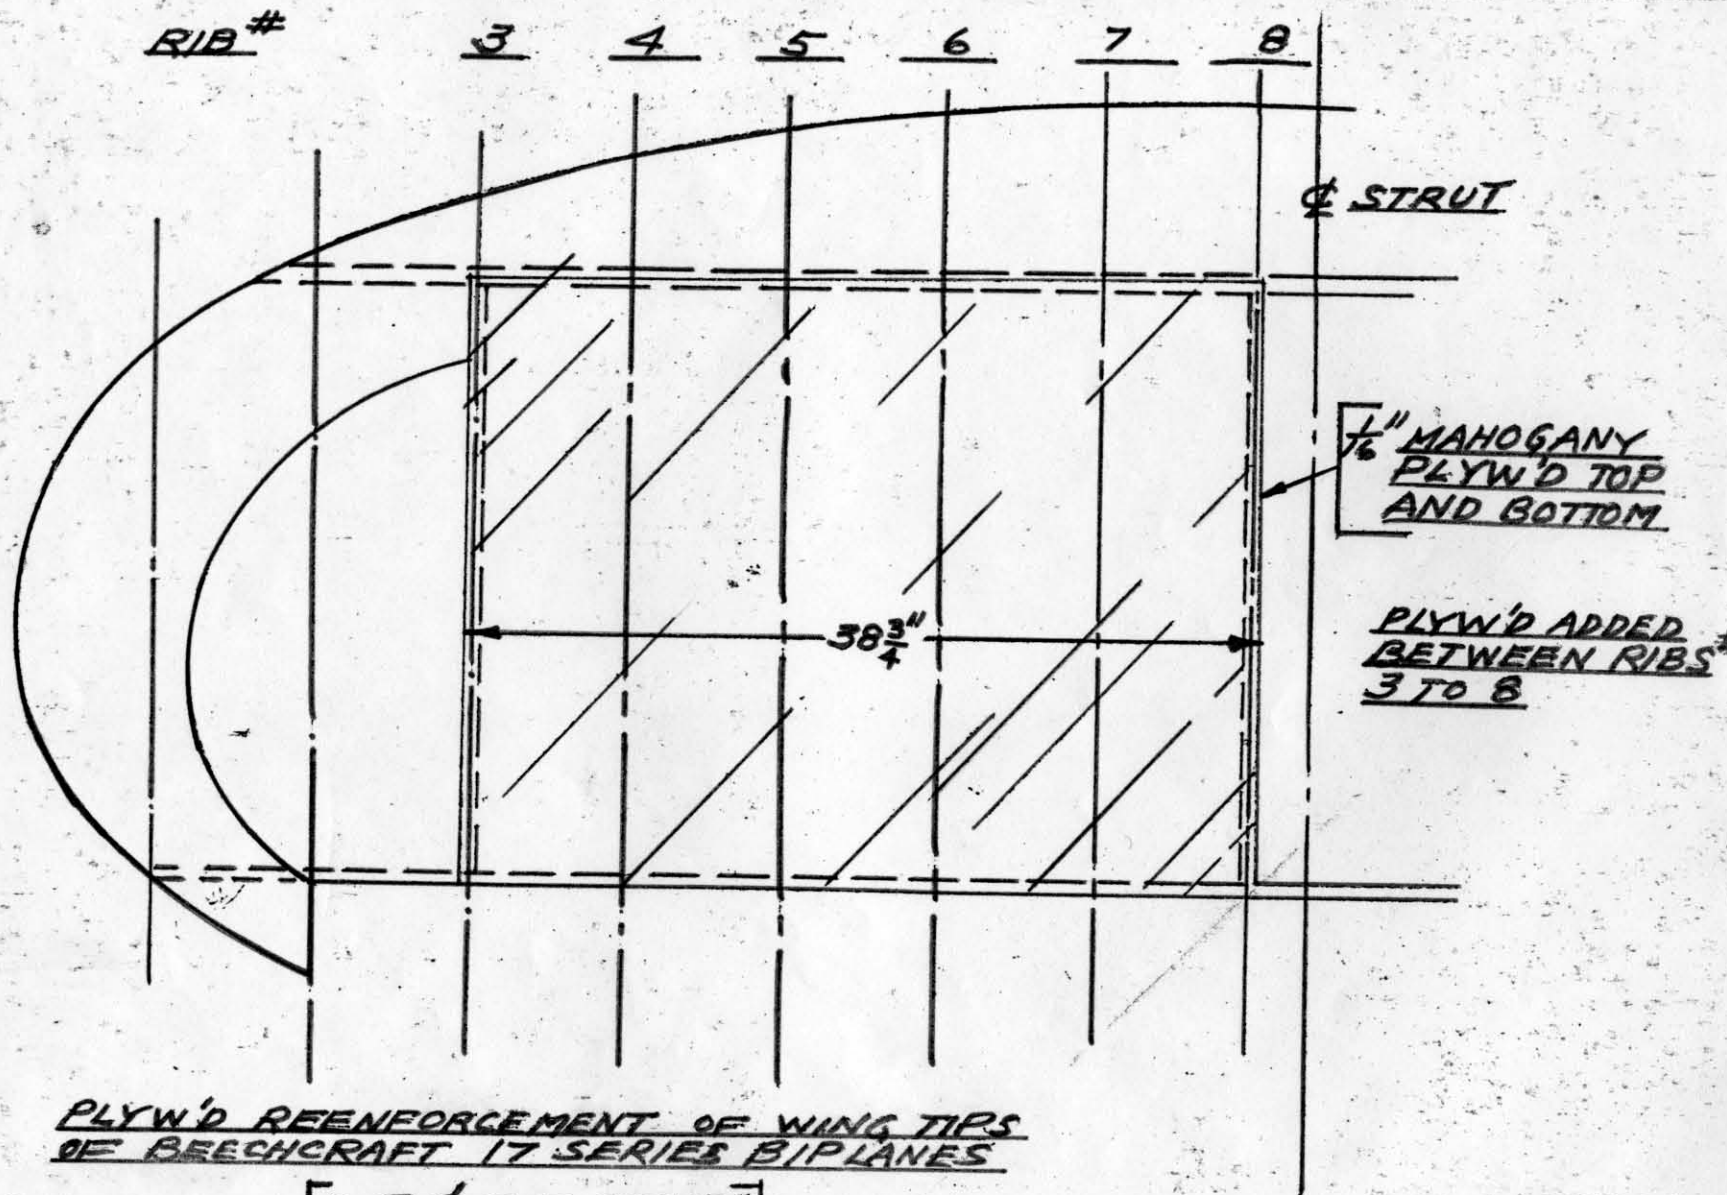
FIGURE 2

PLYW'D REINFORCEMENT OF WING TIPS
OF BEECHCRAFT 17 SERIES BIPLANES

[D, E & F 17 SERIES
AIRPLANES]

A. Increase torsional stiffness of wing tip section (figure 2)

1. For details notice "Beechcraft Service Bulletin No. 75."

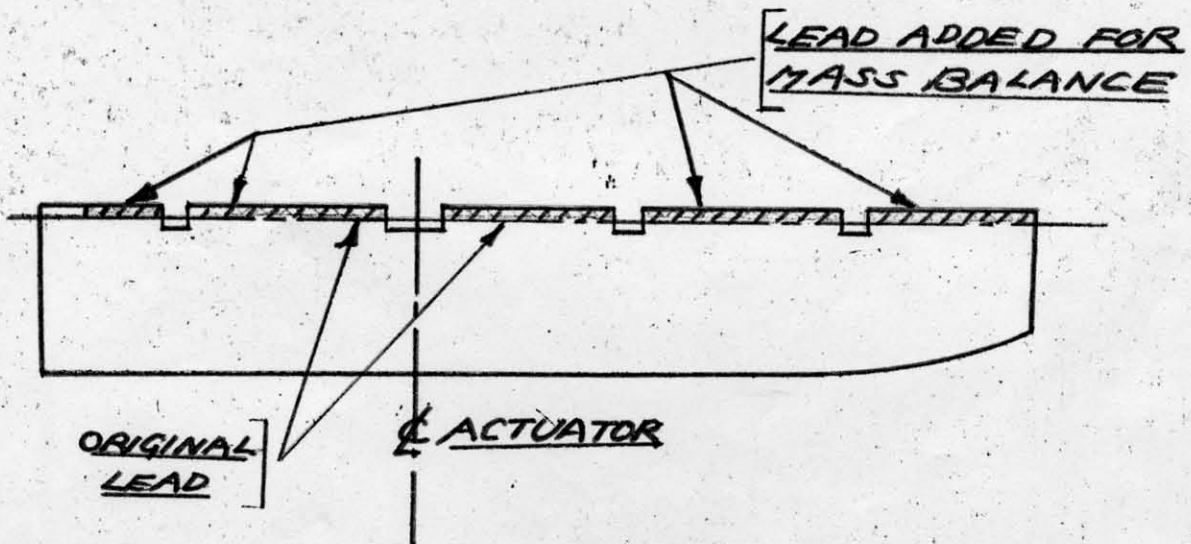
FIGURE 3

MASS BALANCE OF
D, E & F 17 AILERONS

B. Balance the ailerons (figure 3).

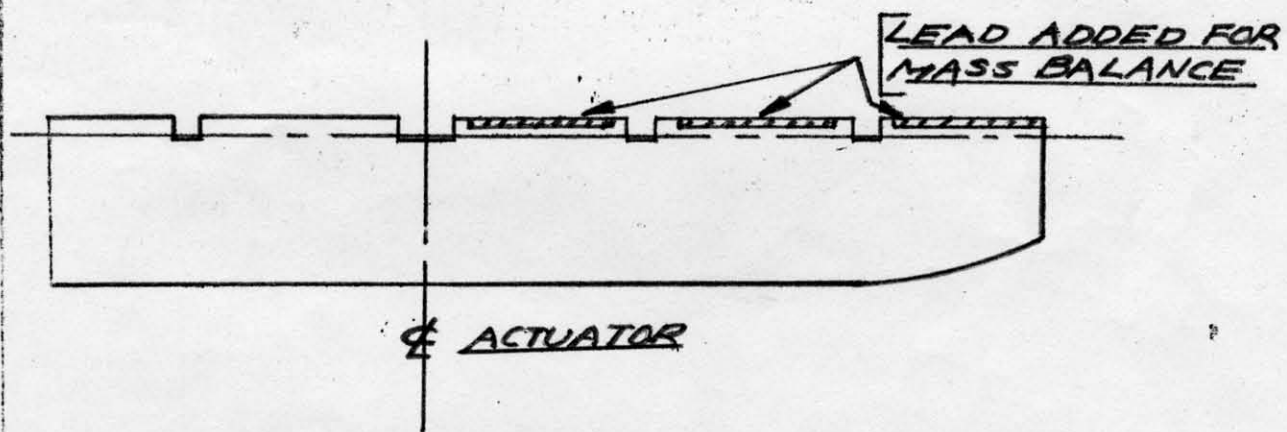
FIGURE 4

MASS BALANCE OF
D, E & F 17 FLAPS

C. Balance the flaps (figure 4).

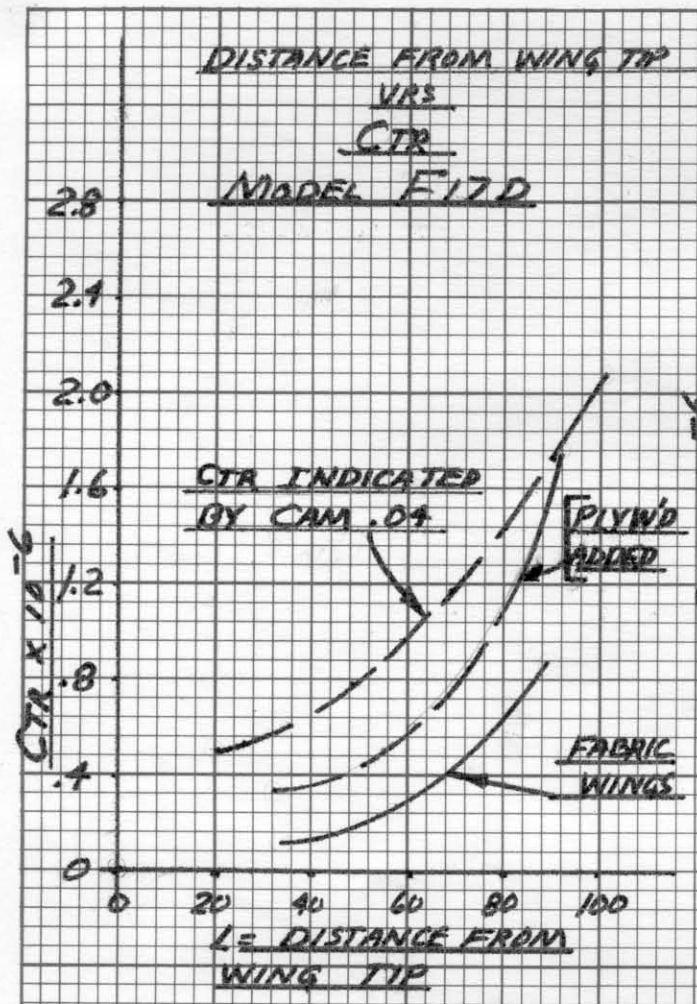
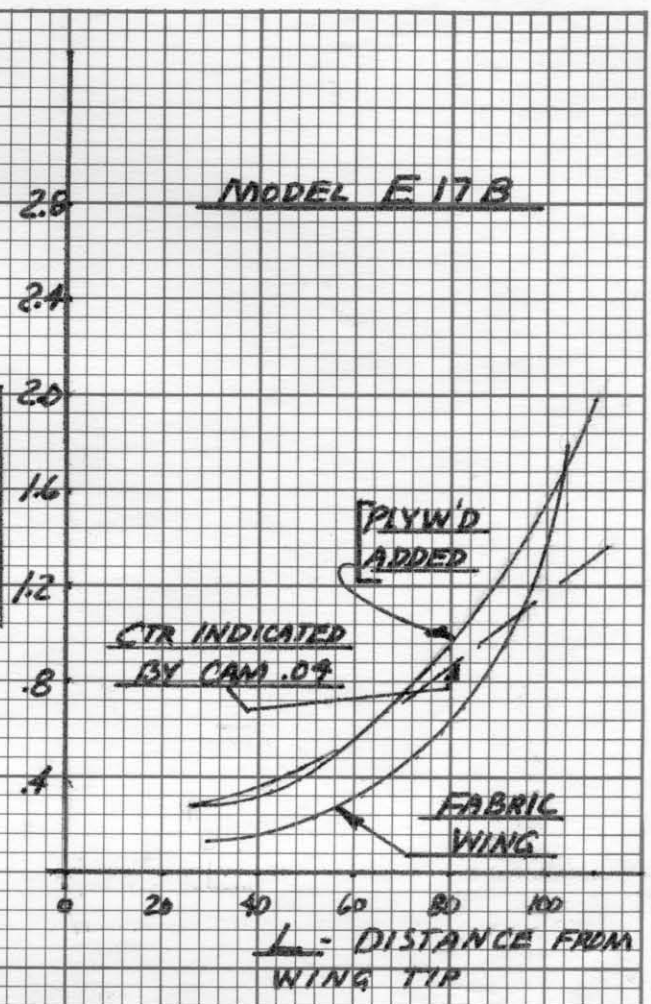
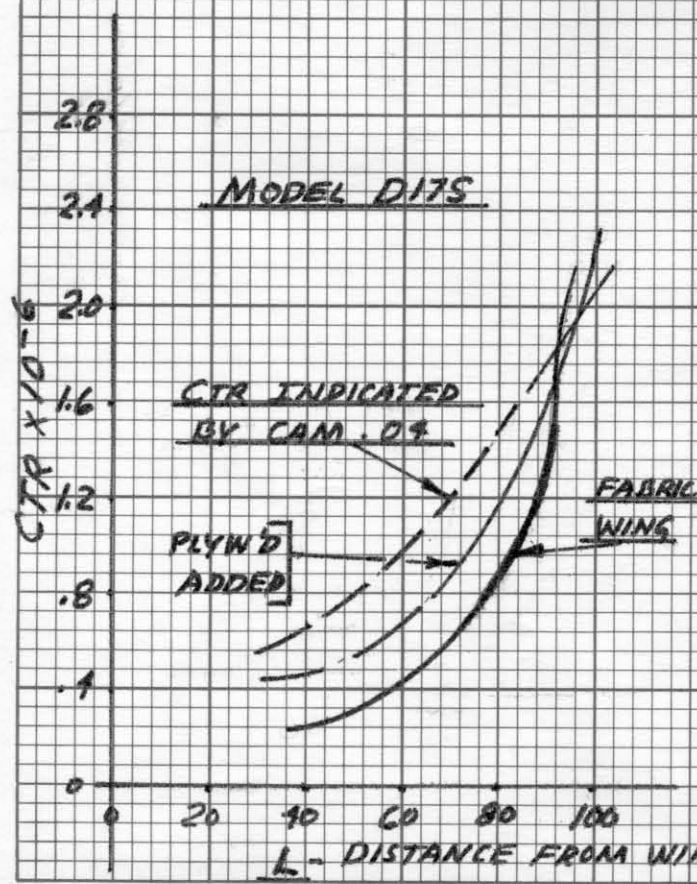
FIGURE 5

1. Torsion tests on Beechcraft Models, (F17D and E17B) in general, consist of:
 - a. Torsion tests on the biplane cellule to determine the C_{TR} values for the basic wing, and subsequent tests to determine the effects on C_{TR} of adding 38 3/4 inches plywood covering to the tip portion of the wings. Notice figure 5.

NOTE:
THESE FIGURES PRESENT A
COMPARISON OF CTR VALUES
OF FABRIC COVERED WING,
PLYW'D COVERING, AND THAT
REQUIRED IN CAM .04.
(NOTE DETAILS OF FABRIC
COVERING ON FIG. 2

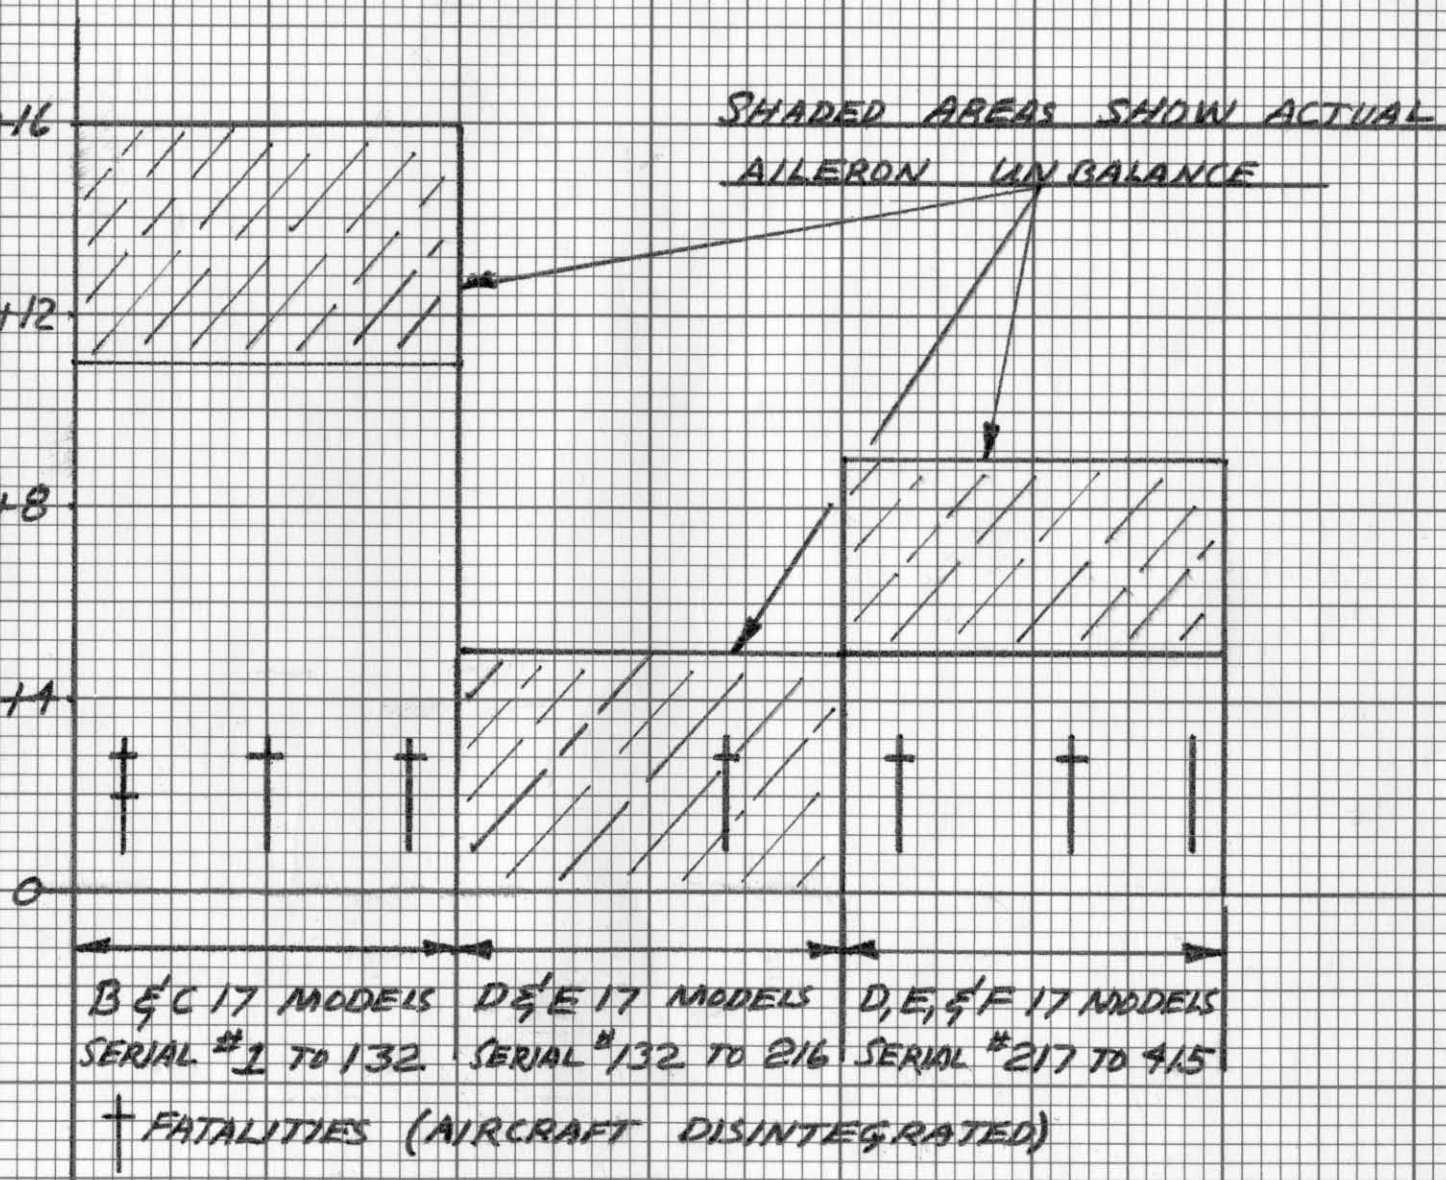
FIGURE 6
BEECHCRAFT

The results of an investigation of actual aileron mass balance, existant in the subject aircraft at the time of the accidents, are shown in figure 6, and tend to indicate the importance of aileron mass-balance for desirable flutter characteristics.

Figure 6 shows quite clearly that aileron flutter difficulties begin to occur with an aileron underbalance of approximately 5#" . No serious flutter difficulties appear to have occurred at a value of +4.0#" . Therefore, the transition point appears to be about 5#" .

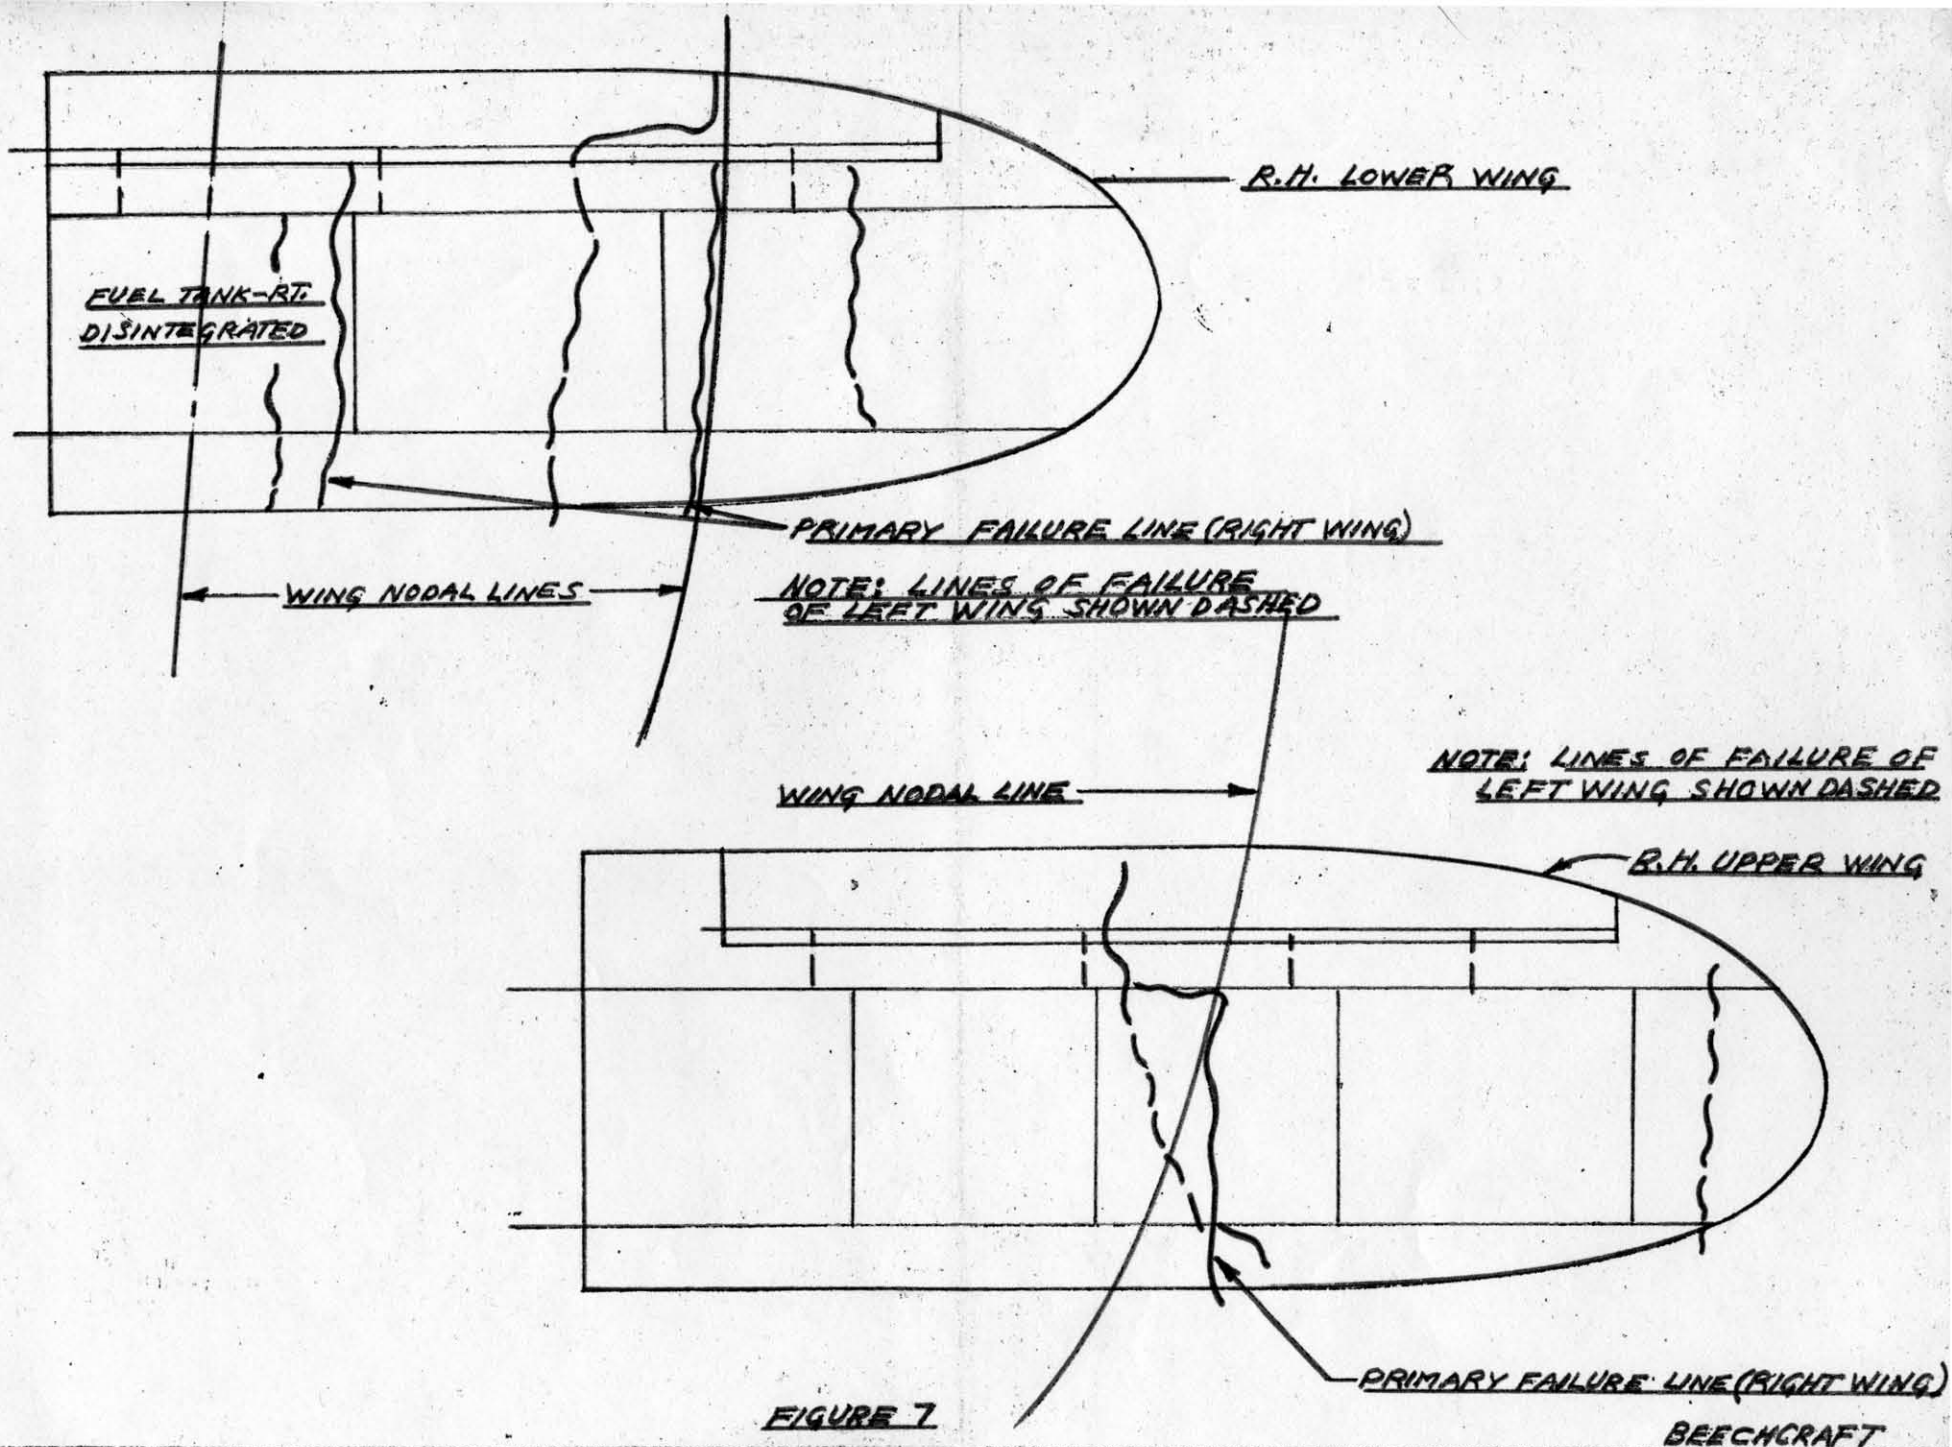
FIGURE 7

Investigation brought out an interesting point and revealed that, when amplitudes are large, lines of breakage are likely to occur adjacent to nodal lines. The lines of failure of a Beechcraft wing cellule are shown on figure 7.
